# Motorola T-1504 Duplexer Refurb / AI6BX

## Photos Taken During Service/Refurbishing

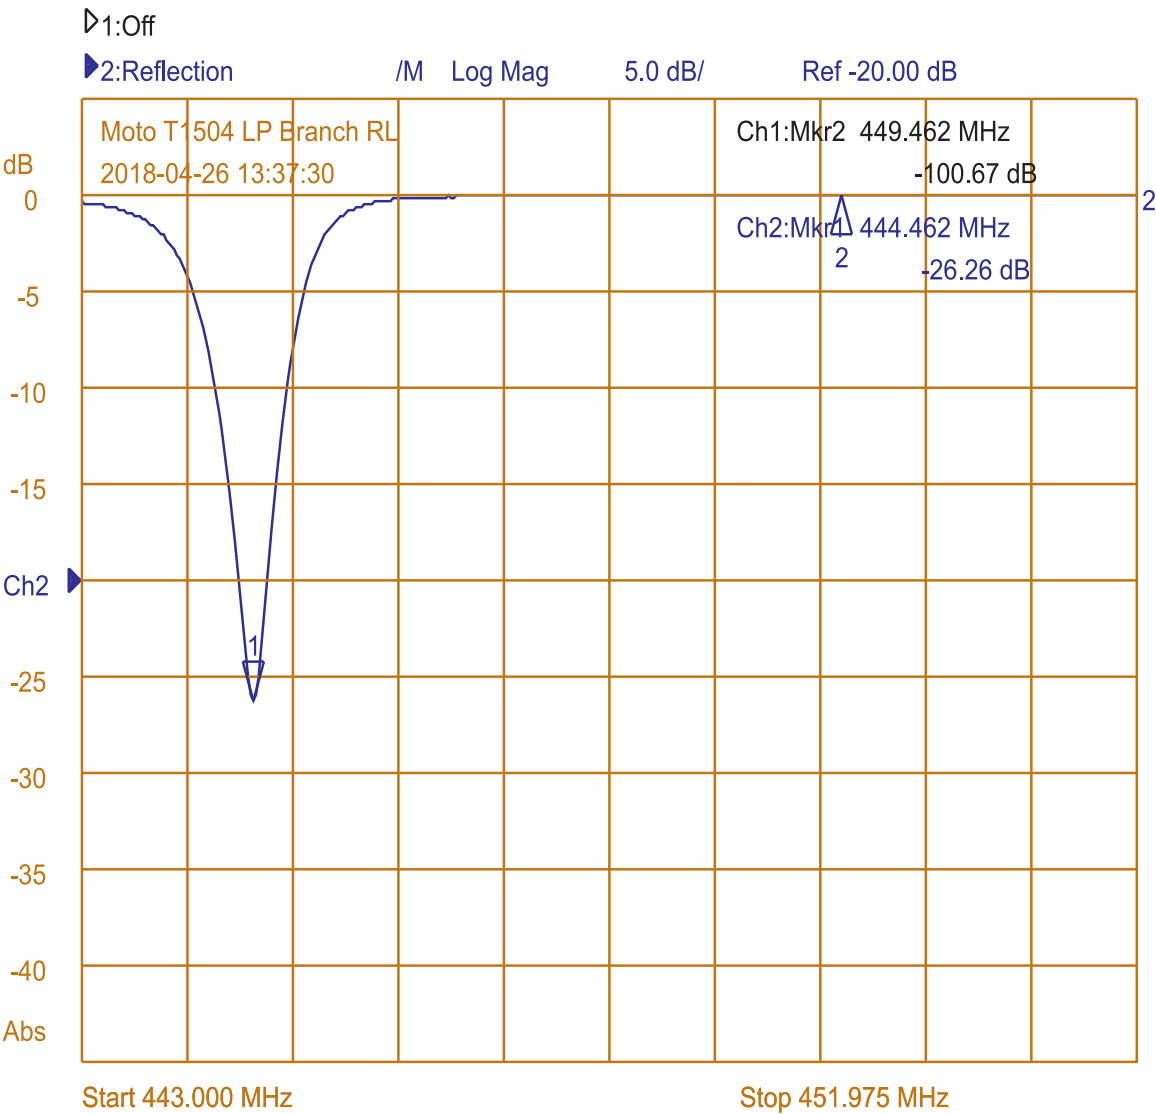
## Low Pass Branch Return Loss

| 1:Mkr (MHz) dB | 2:Mkr (MHz) dB |
|---|---|
| | 1> 444.46 -26.26 |
| | 2: 449.46 0.02 |
| VSWR: 1.102:1 | |

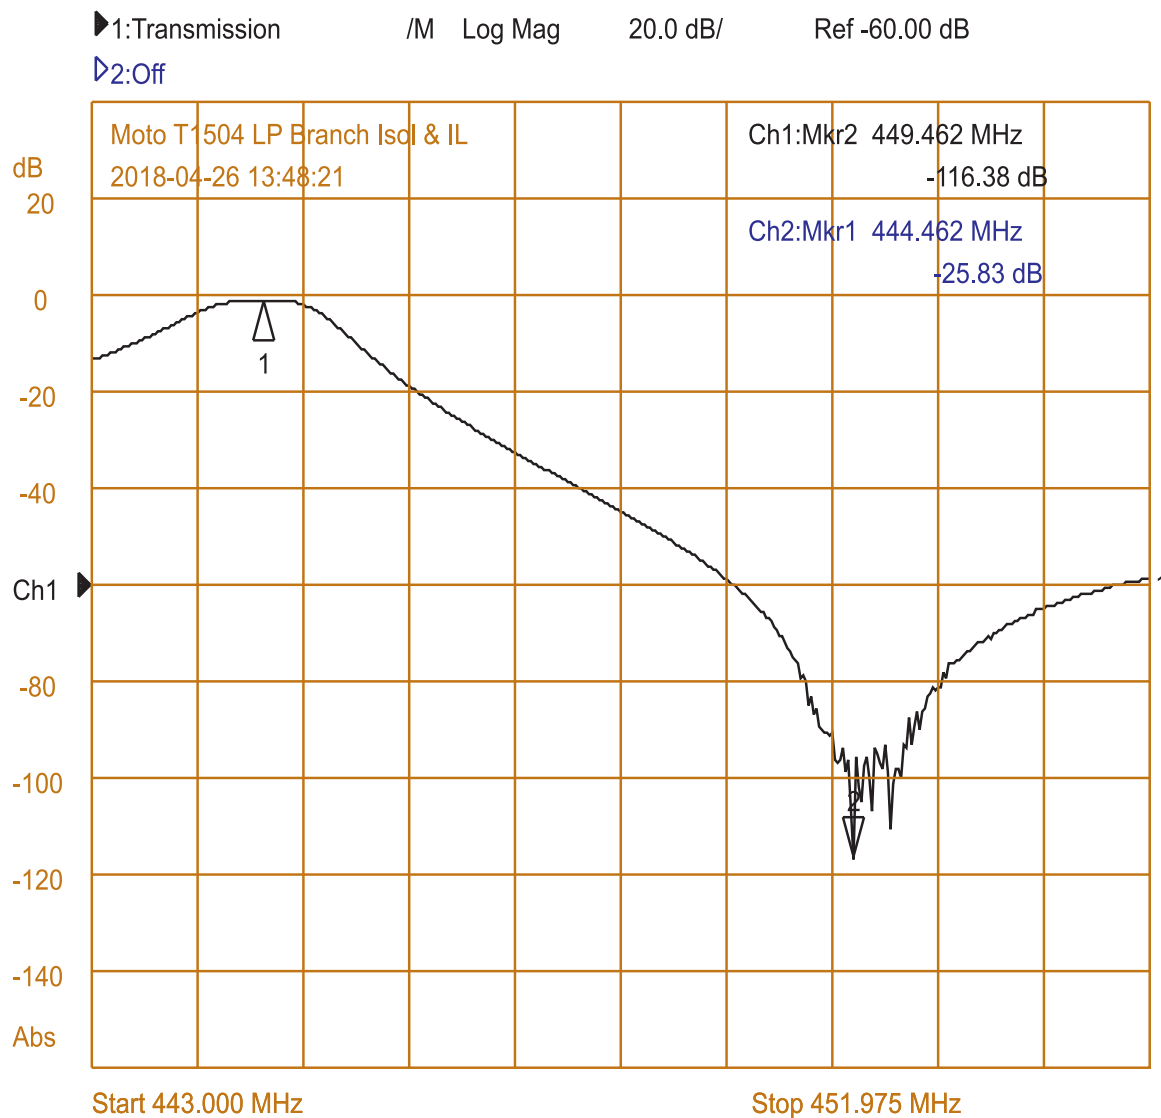
## Low Pass Branch Isolation & Insertion Loss

| 1:Mkr (MHz) dB | 2:Mkr (MHz) dB |
|--|---|
| 1: 444.46 -0.99 | |
| 2> 449.46 -116.38 | |
| <b>Isolation: 116.38 dB</b><br><b>Ins. Loss: 0.99 dB</b> | |

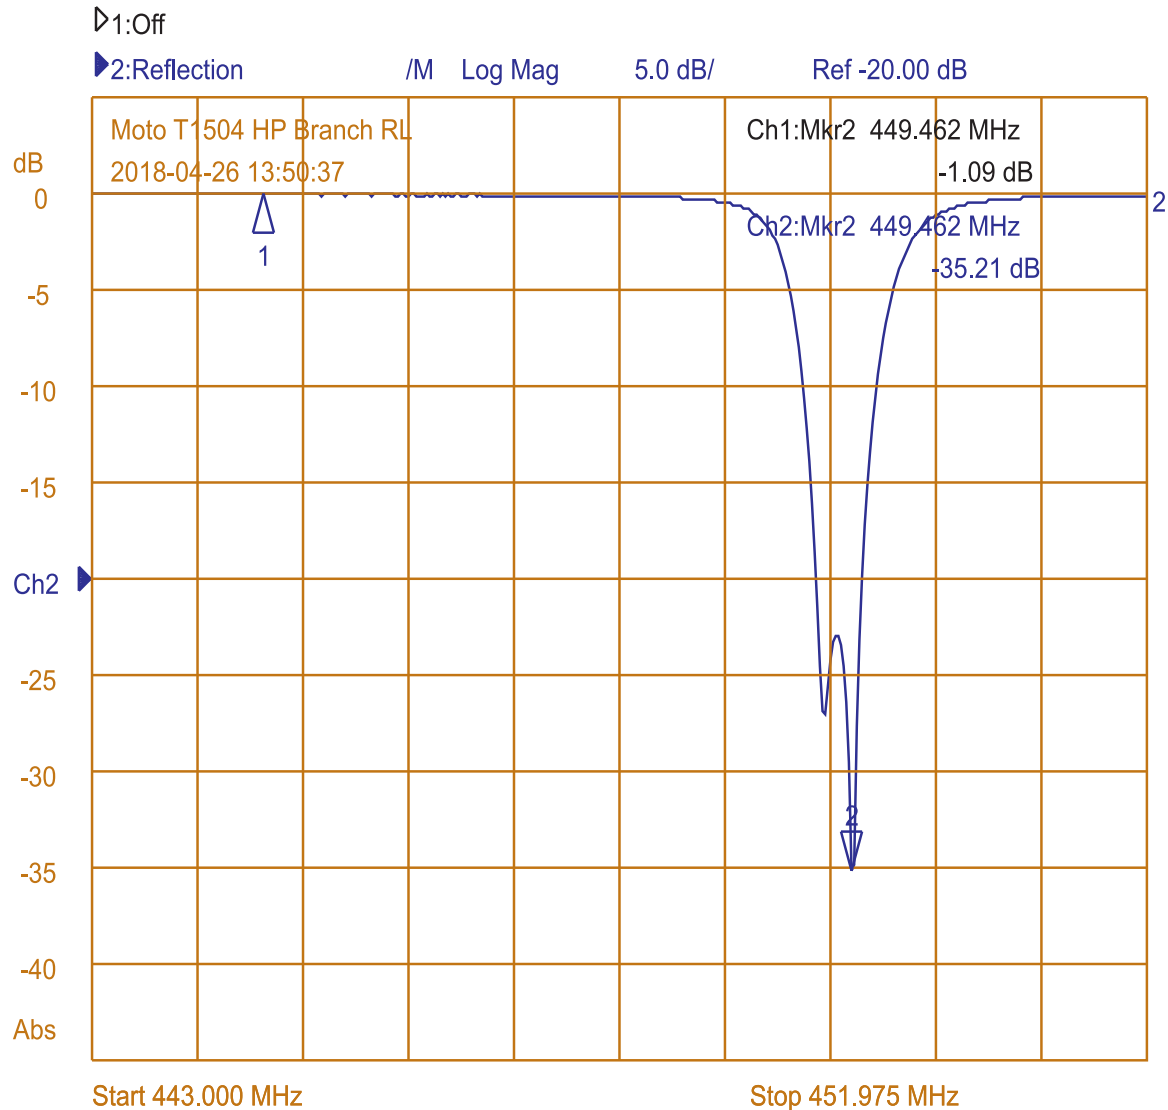
## High Pass Branch Return Loss

| 1:Mkr (MHz) dB | 2:Mkr (MHz) dB |
|---|---|
| | 1: 444.46 -0.07<br>2> 449.46 -35.21 |
| VSWR: 1.035:1 | |

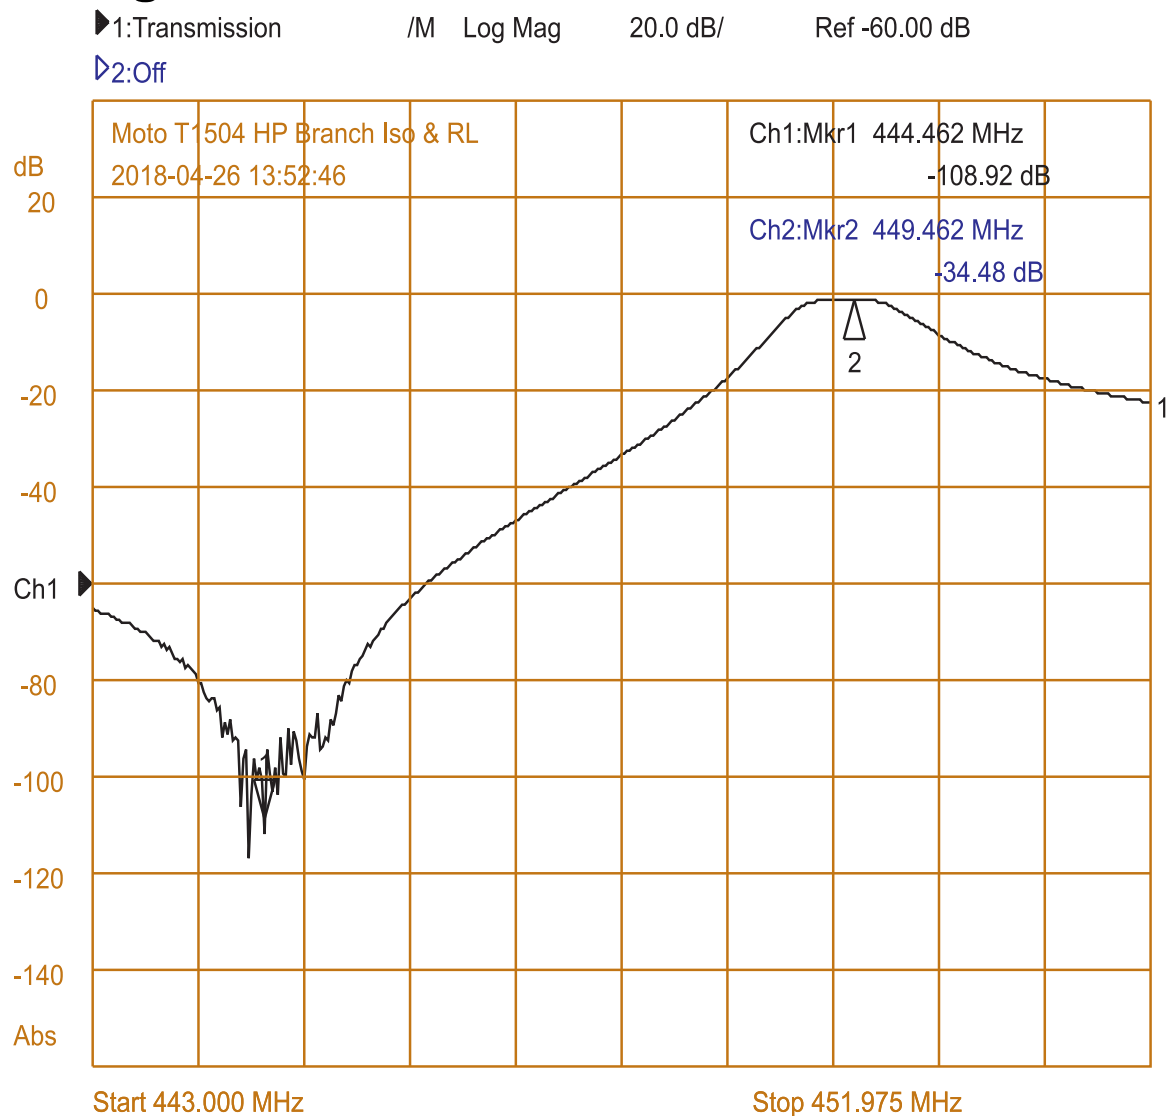
## High Pass Branch Isolation & Insertion Loss

| 1:Mkr (MHz) dB | 2:Mkr (MHz) dB |
|--|---|
| 1> 444.46 -108.92 | |
| 2: 449.46 -1.09 | |
| <b>Isolation: 108.92 dB</b><br><b>Ins. Loss: 1.09 dB</b> | |

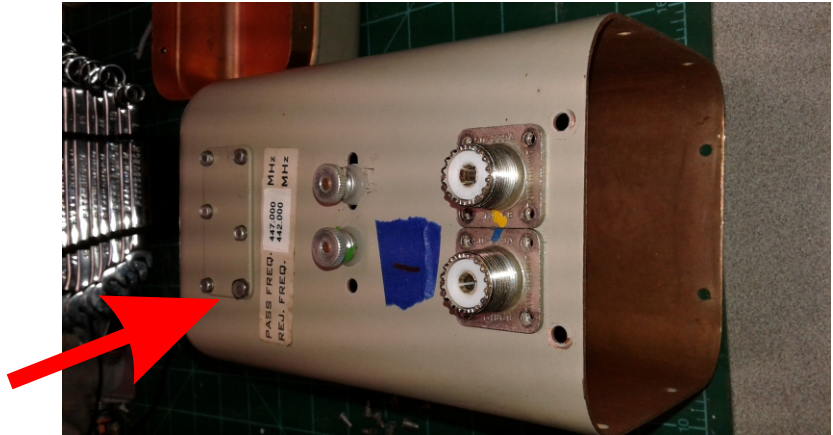
*This odd screw (along with the fact that two of the four tuning rod lock nuts are not original parts) leads me to conclude that someone has been inside this cavity before, and that two of the four cavities may not be original to the duplexer assembly. Also, this cavity and the other cavity with incorrect rod locking nuts had considerable corrosion in the copper tuning cylinder and plunger assemblies, evidence of significant moisture ingress at some point in time, as compared to the other two cavities, which appeared to be in overall decent condition with no similar signs of moisture damage.*

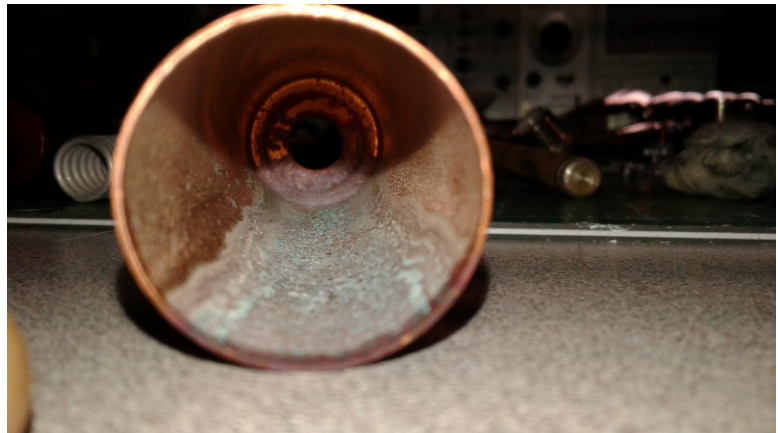
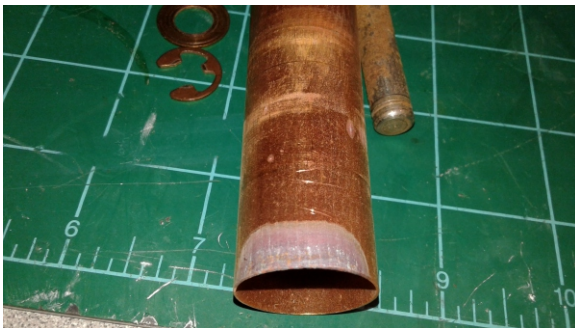
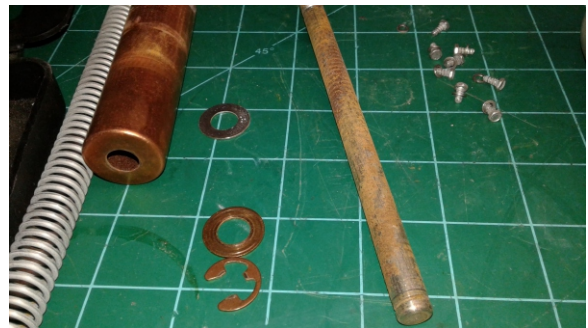
*Corrosion in tuning plunger from moisture incursion in cavity. Also note corrosion on outside of plunger and rusting/corrosion of the steel tuning rod, both seen in the photos below.*
