**WACQ 98.5**  
**Marti Receiver & STL Antenna Realignment**  
**and Translater Broadcast Startup**  
**February 14, 2019**

**Marti Studio-to-Transmitter Link (STL) receiver front-end realigned and associated antenna realigned for maximum signal quality.**  
**Station programming began audibly broadcasting on this 98.5 MHz Low Power F.M. (LPFM) frequency at approximately 12:55 p.m. this date.**

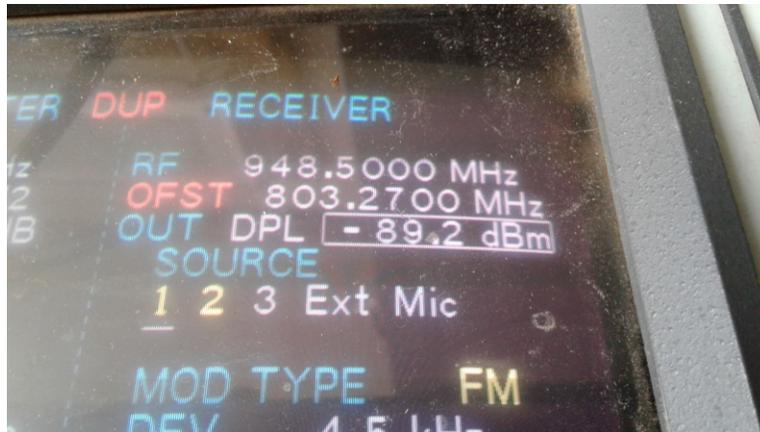
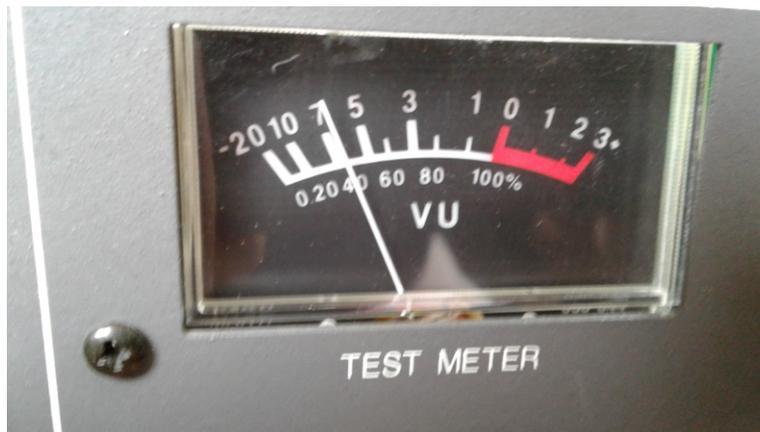
Figures 1 and 2: Arrived at transmitter/tower site at approximately 12:00 p.m. On arrival, noted Marti unit was connected to antenna, but the receiver's squelch was not opening and no signal was being passed from the STL receiver to the station's transmitter. Removed receiver from rack and tested with IFR service monitor. A test signal of -89.2 dBm would only produce a "-7" signal level on the receiver, indicative of need for 1st stage ("front end") of the receiver to be realigned, which was in agreement with what Terry Harper had stated appeared to be the problem. The STL transmitter and receiver frequency had been bumped-up 3 MHz, which was outside the previous tuned range of the receiver.

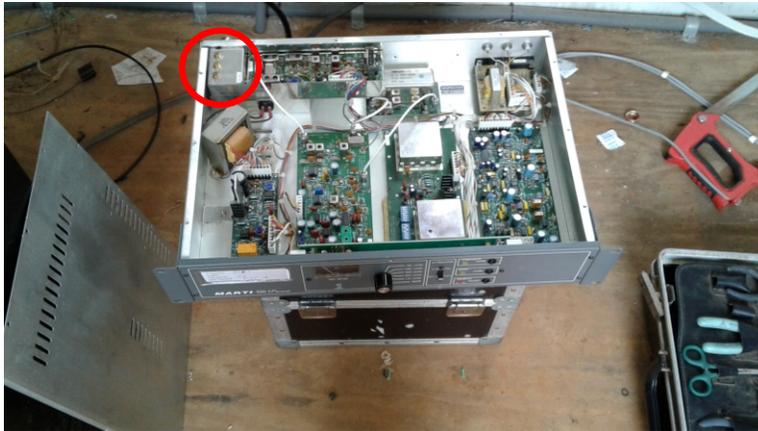
Figure 3: Marti receiver cover removed for access to tuning adjustments. The only adjustment needed was correct tuning of the three Johanson-type capacitors in the first stage filter (indicated in the circled area in the photo.)

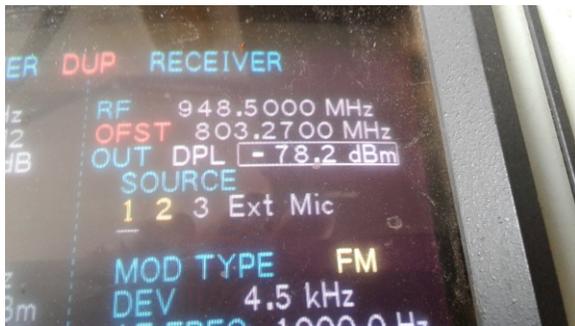
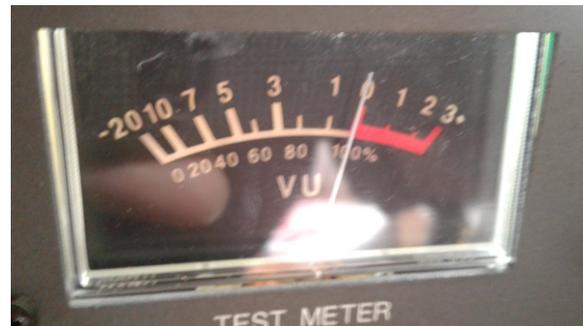
Figures 4 and 5: With front-end of receiver realigned, a -78.2 dBm signal would produce a "0" level on the Marti receiver with the receiver's 10 dB attenuation switch turned on.

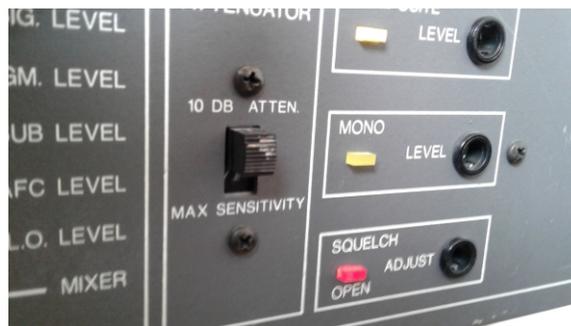
Figure 6: After realignment, signal levels well below -78.2 dBm resulted in squelch opening and test tone detection.

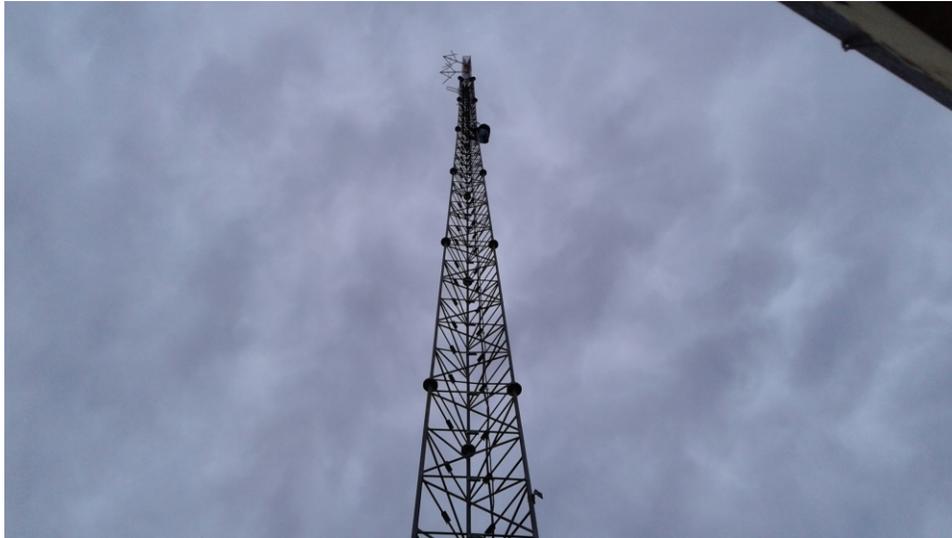
Figure 7: Eric Duncan, tower rigger with Duncan & Sons, ascending tower in order to realign the azimuth of the STL antenna in order to peak the received STL signal level.

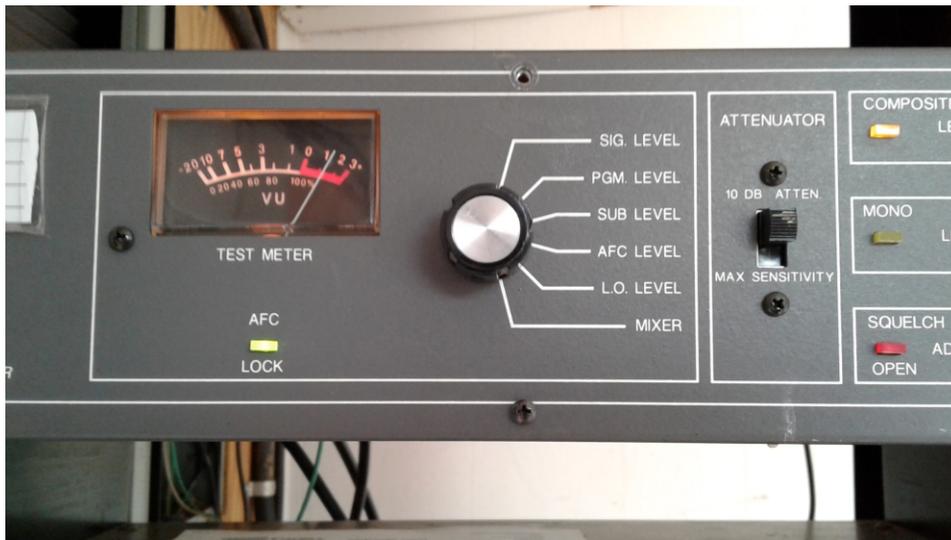
Figure 8: After STL antenna realignment, the receiver was showing just above a “+1” level on its built-in meter with the 10 dB attenuation switch turned on. I did not visit the studio to check the transmit level setting on the Marti STL transmitter, but there appears to be more than ample signal and path quality to possibly reduce the Marti transmitter level and switch the 10 dB attenuation switch from the 10 dB Attenuation position to the “Maximum Sensitivity” position, although that is merely an option which could potentially extend the life of the Marti STL transmitter’s amplifier if it is currently adjusted to anywhere near its highest output level. **Adjusted 250 Watt 98.5 FM broadcast transmitter deviation level to peak at just a “tick” mark above 100% level.**
