# Motorola T-1504 Duplexer Refurb / AI6BX

## Photos Taken During Service/Refurbishing

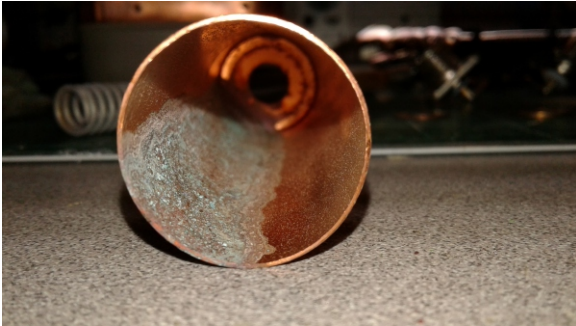
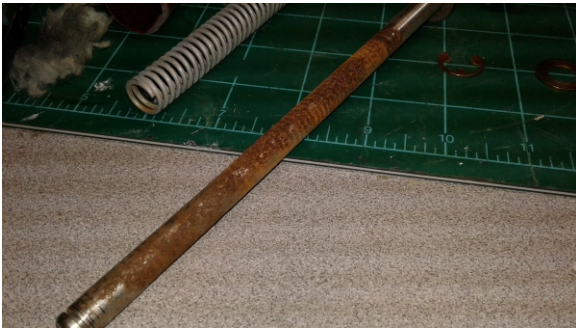
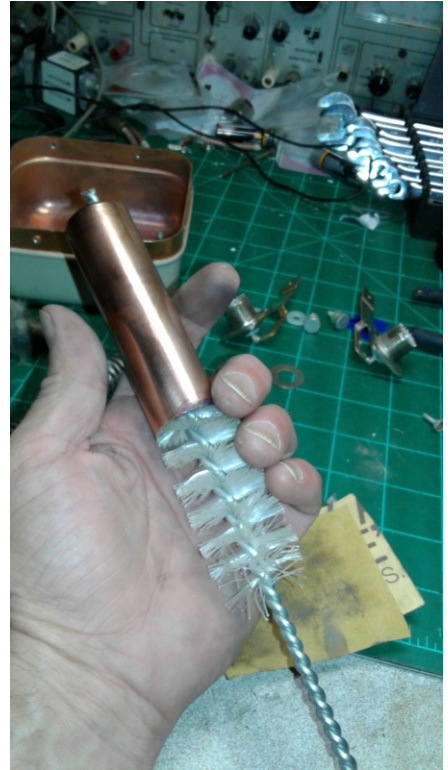
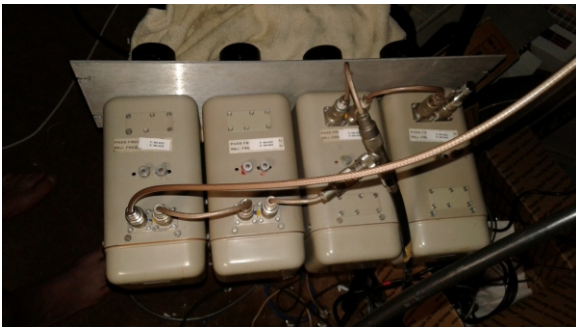
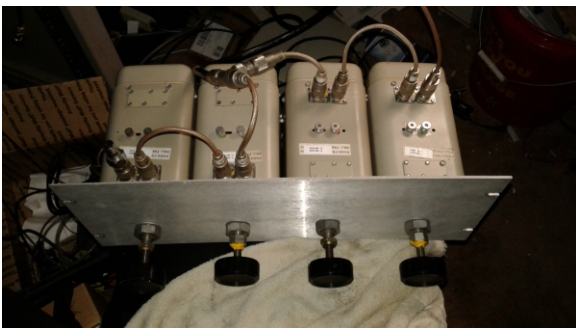
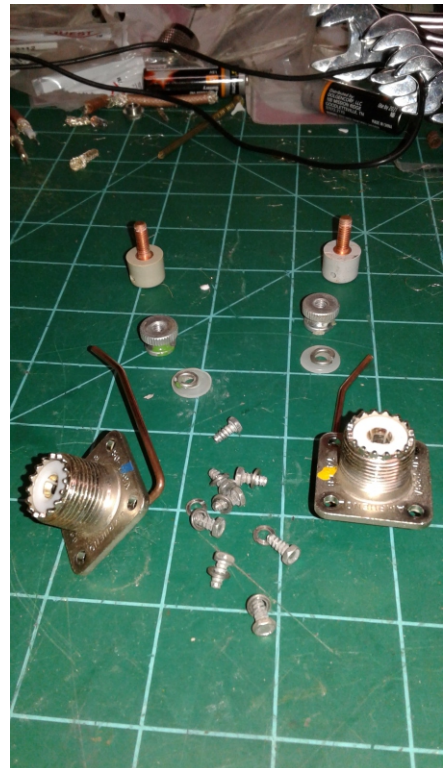
*This odd screw (along with the fact that two of the four tuning rod lock nuts are not original parts) leads me to conclude that someone has been inside this cavity before, and that two of the four cavities may not be original to the duplexer assembly. Also, this cavity and the other cavity with incorrect rod locking nuts had considerable corrosion in the copper tuning cylinder and plunger assemblies, evidence of significant moisture ingress at some point in time, as compared to the other two cavities, which appeared to be in overall decent condition with no similar signs of moisture damage.*

*Corrosion in tuning plunger from moisture incursion in cavity. Also note corrosion on outside of plunger and rusting/corrosion of the steel tuning rod, both seen in the photos below.*
